CATALA HOUSE  
17315 SE 42ND COURT BELLEVUE, WA 98006

# GEOTECHNICAL REPORT PROPOSED RESIDENCE 17315 Southeast 42<sup>nd</sup> Court Bellevue, Washington

PROJECT NO. 14-133.200  
March 2017

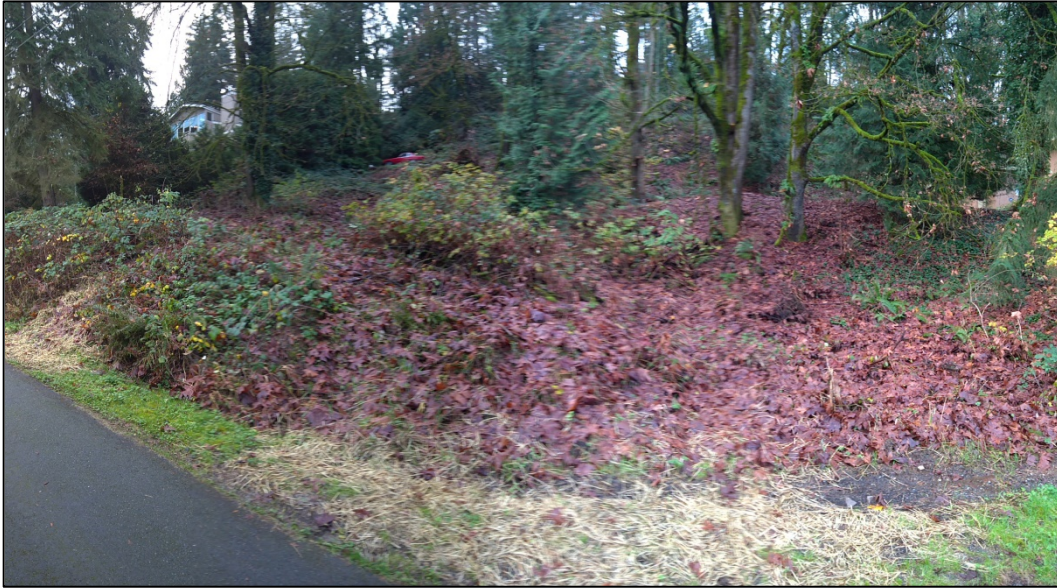
**Plate 1:** View from northwest corner of the site to the southeast.

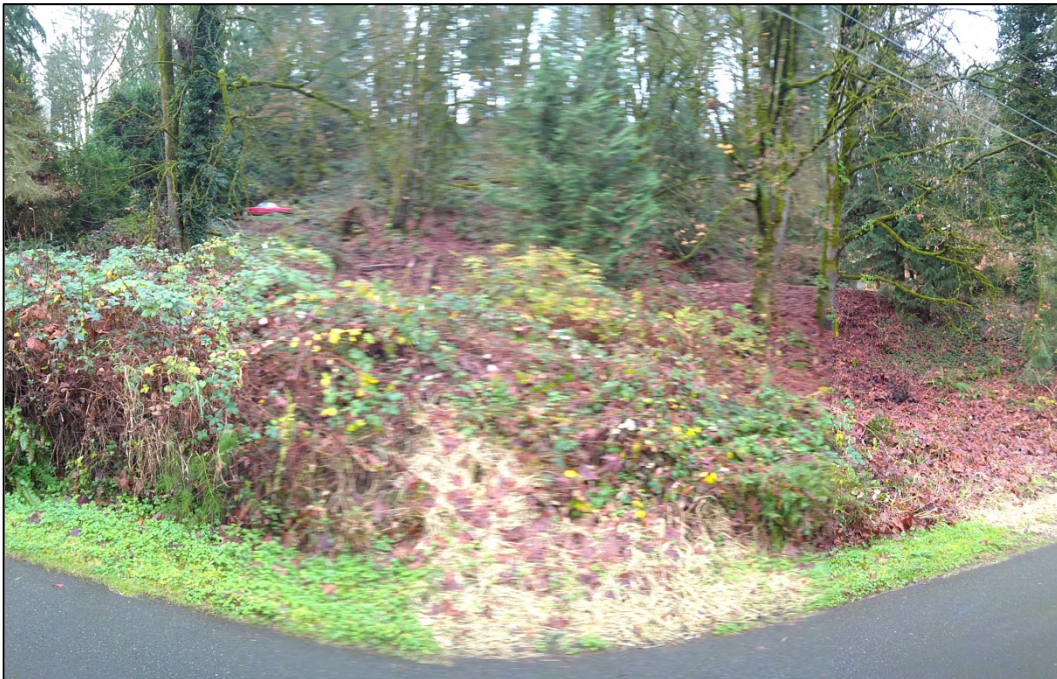
**Plate 2:** View from northeast portion of the site to the southwest.

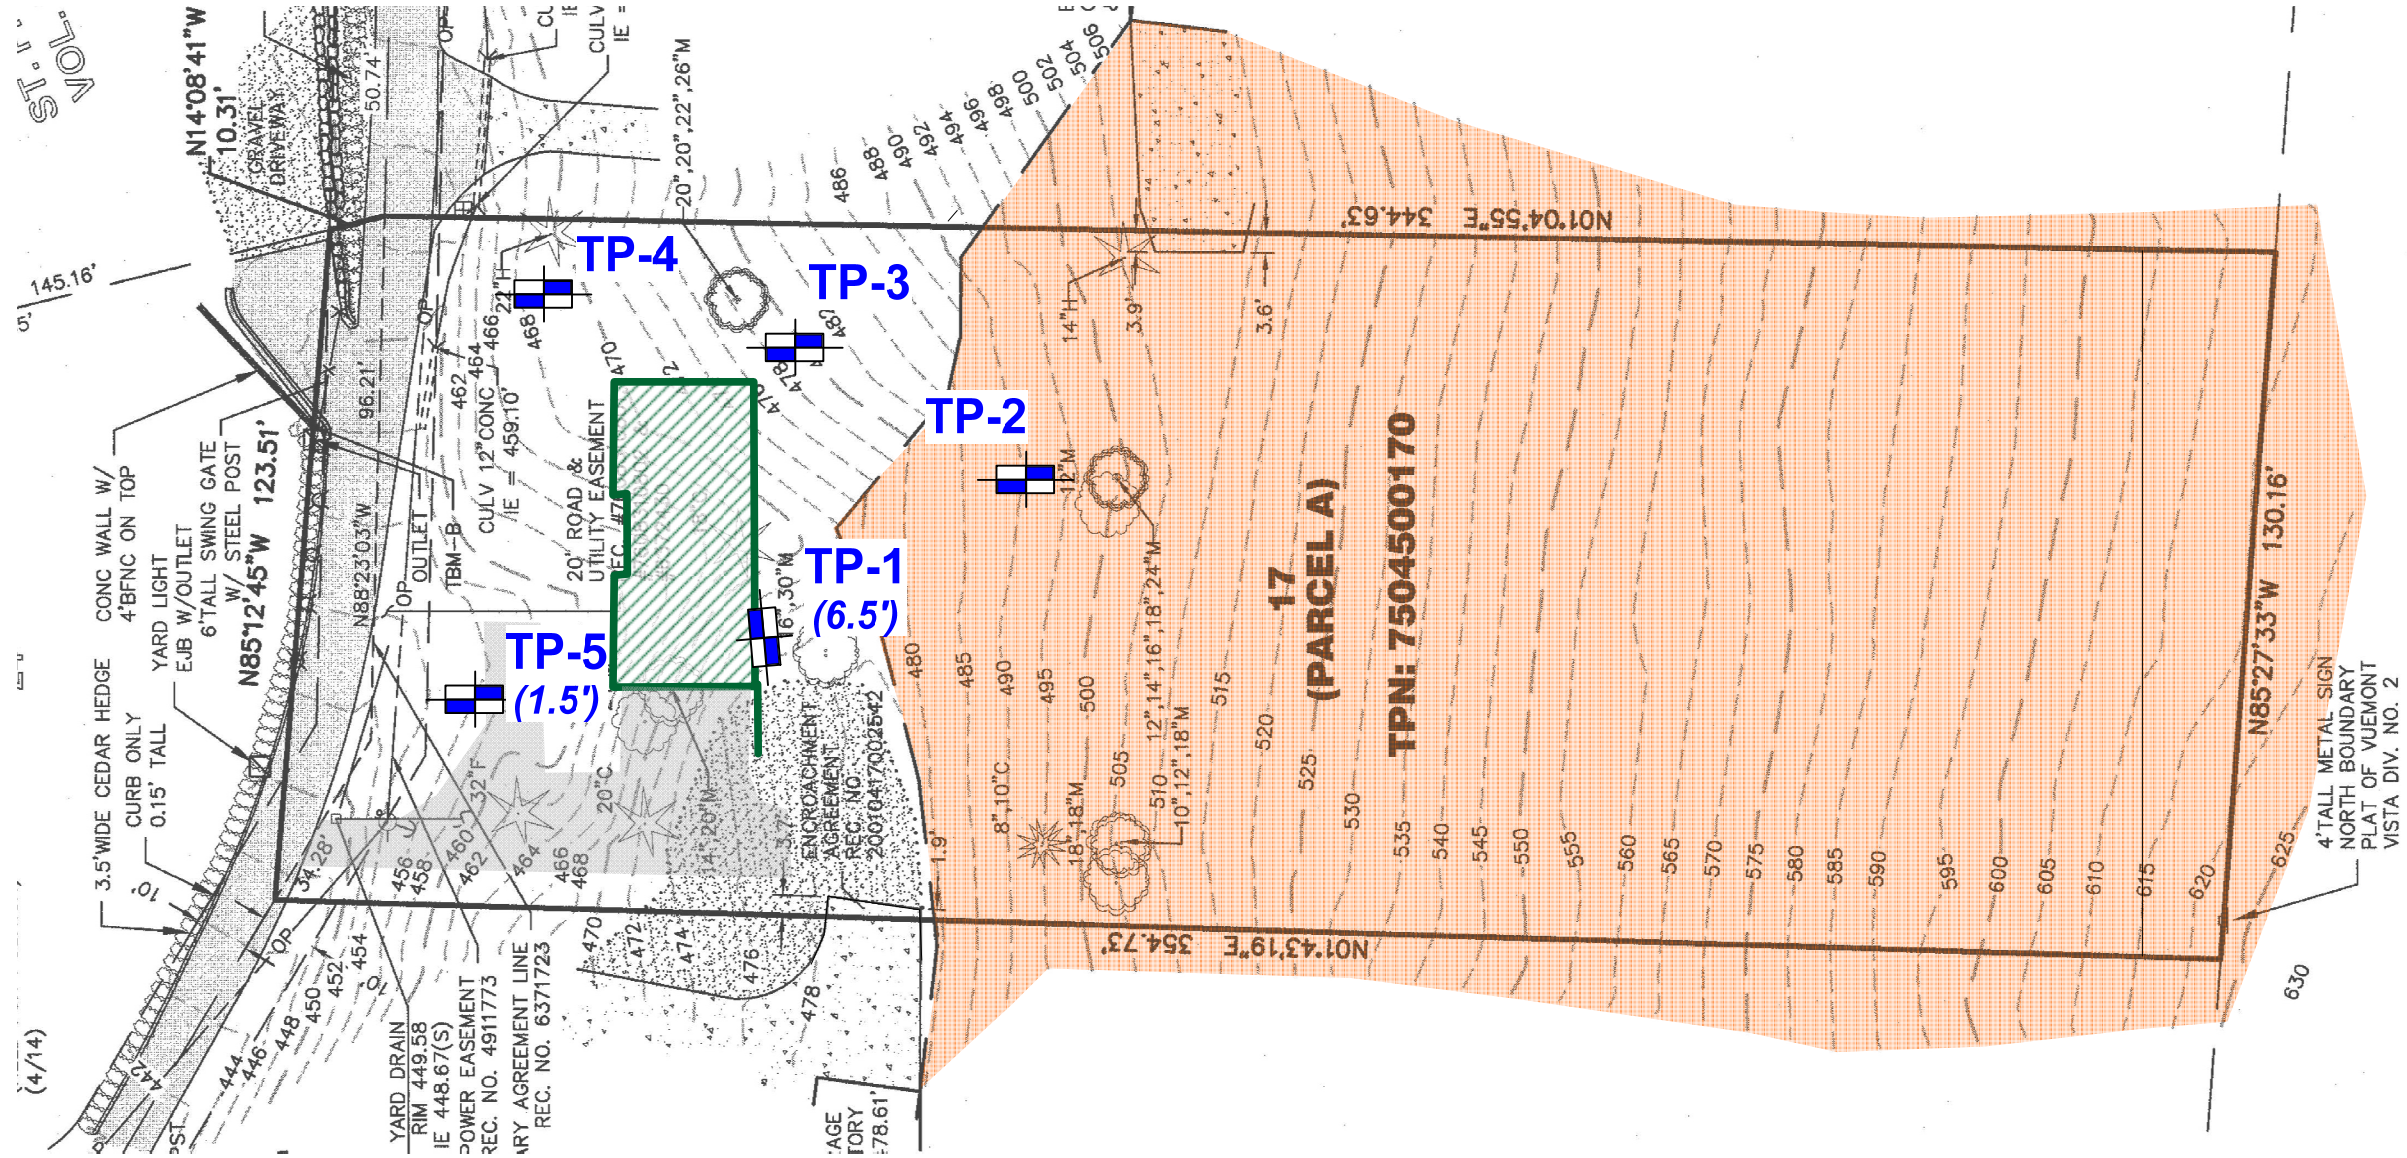
Figure No. **2**

The south portion of the site has a slope gradient in excess of 40 percent, a slope height of more than 140 feet and exceeds 1,000 square feet in area. As such, the slope in the south portion of the site meets the criteria of a Bellevue LUC defined steep slope hazard area. The extent of the steep slope hazard area is approximately shown on Figure 2.

In order to reduce the construction setback from the south slope, we recommend providing a debris flow catchment on the south side of the proposed residence. The catchment may consist of a landscaped soil berm or a catchment wall incorporated into the structure. A horizontal distance of 10 feet should be maintained between the proposed house and the catchment wall/berm.

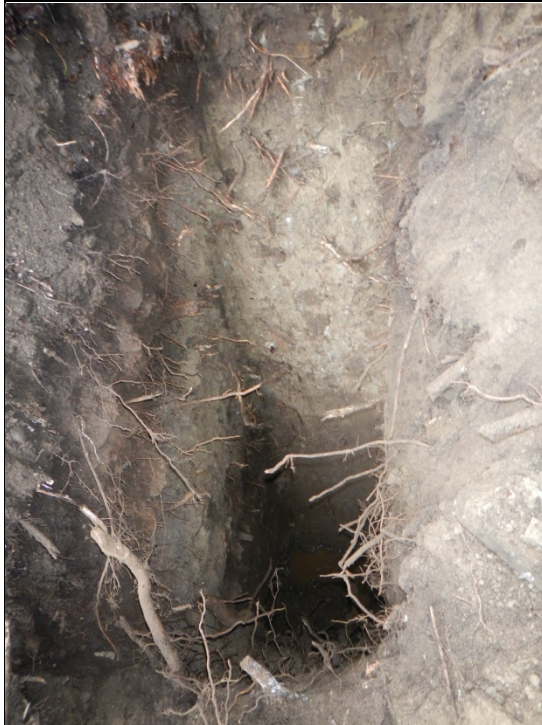
**Test Pit TP-1:** View of west side of Test Pit TP-1. Completed depth of 9 feet below grade.

Test pit terminated at 9.0 feet below grade.  
Moderate groundwater seepage encountered at 7 feet during excavation.

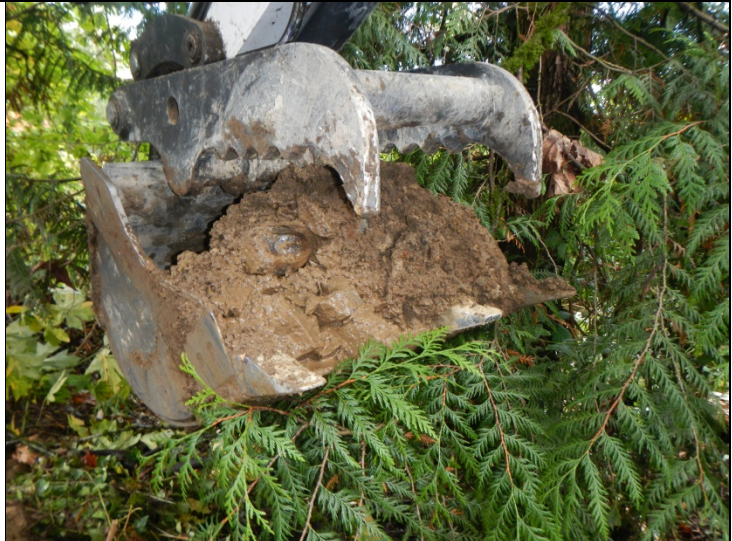
**Test Pit TP-1:** Highly weathered siltstone from about 9 feet below grade.

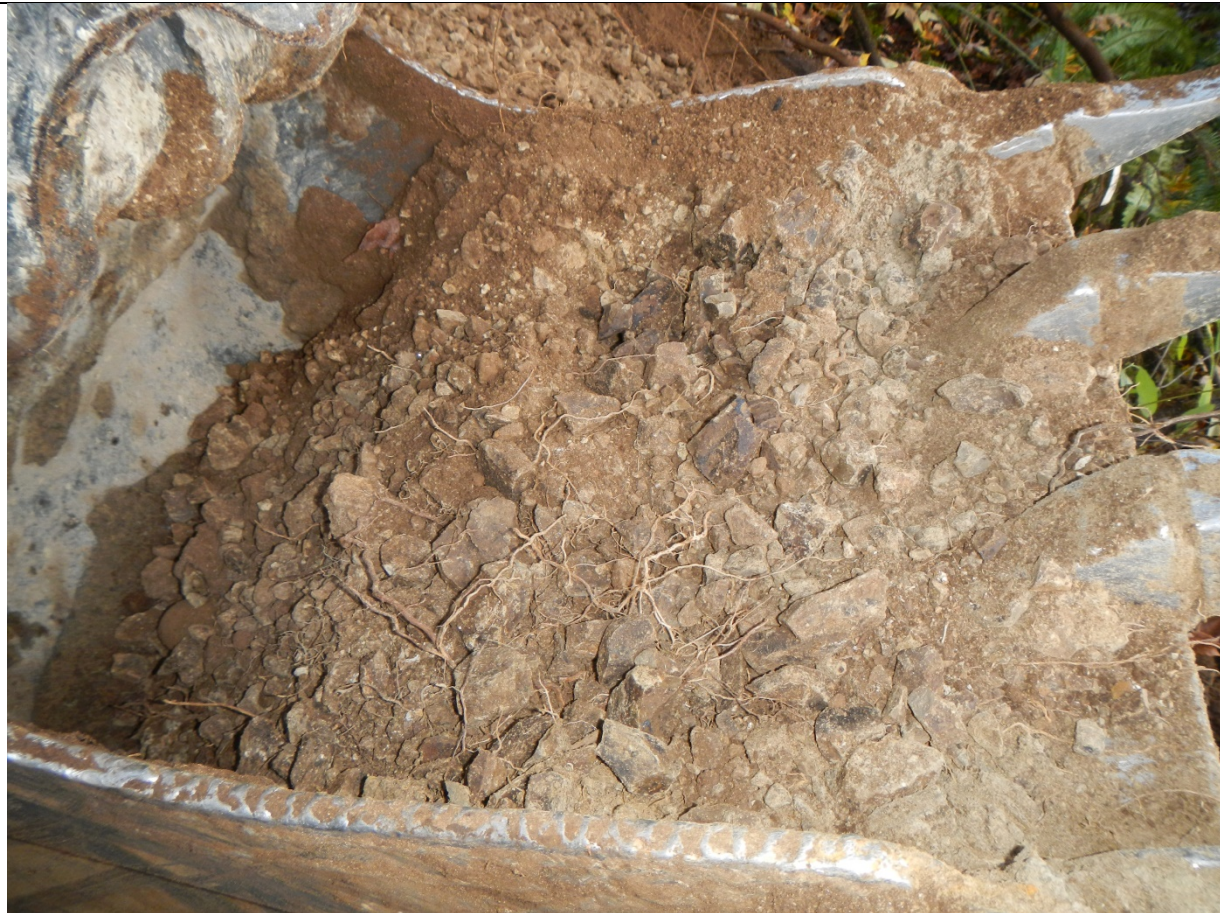
**Test Pit TP-2:** View of excavation spoils consisting of angular sandstone gravel sized particles. Material is from about four feet below grade.

Test pit terminated at 4.5 feet below grade.

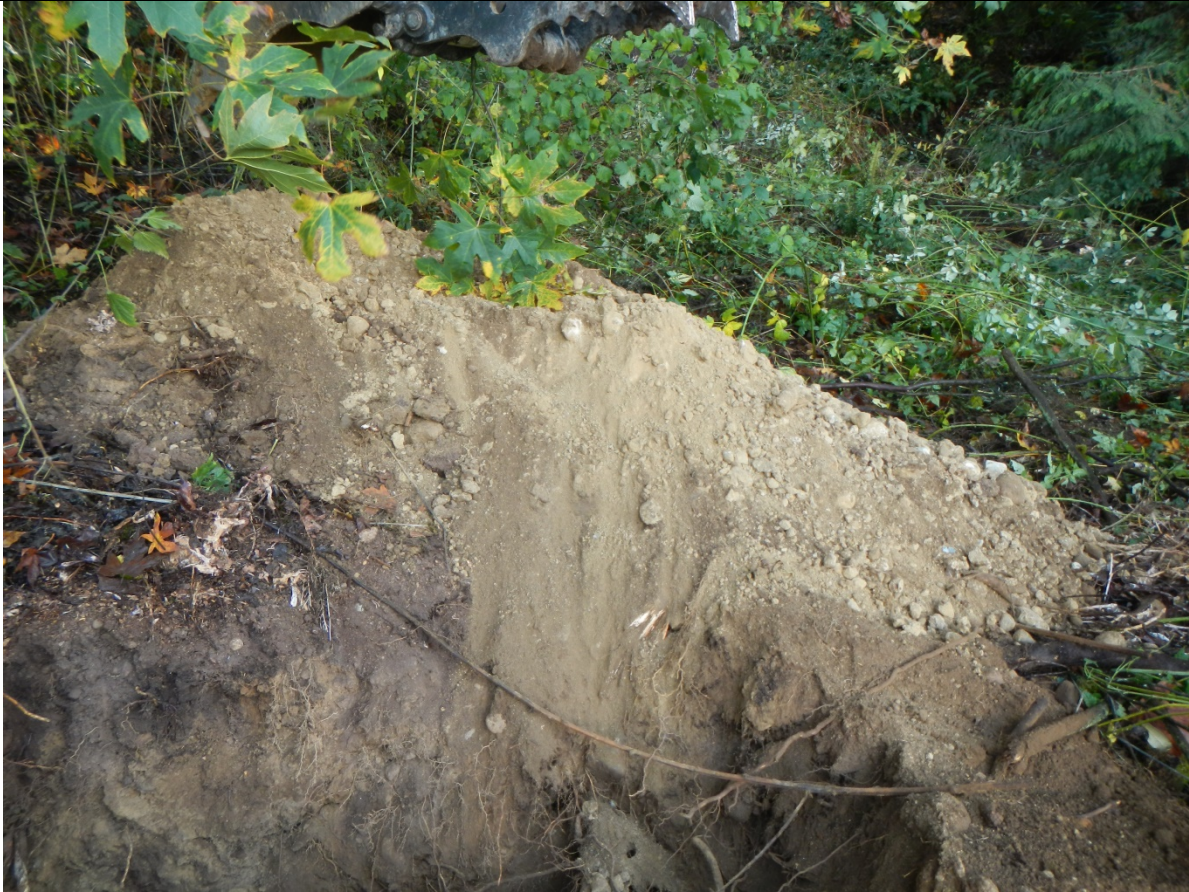
**Test Pit TP-3:** View of spoils pile from Test Pit TP-3.

Test pit terminated at 6.5 feet below grade.  
No groundwater seepage encountered during excavation.

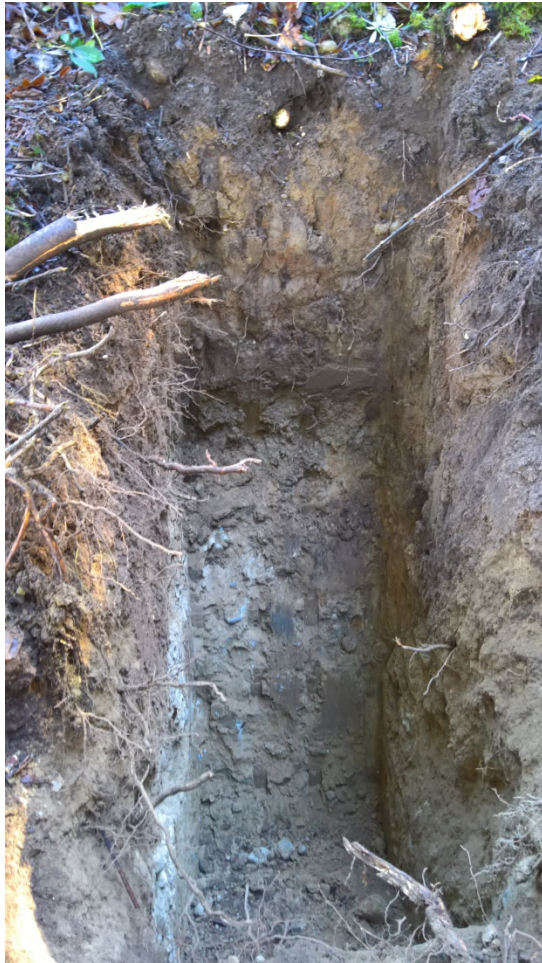
**Test Pit TP-4:** View of south end of Test Pit TP-4. Test Pit is approximately 7 feet deep.

Test pit terminated at 7 feet below grade.  
No groundwater seepage encountered during excavation.

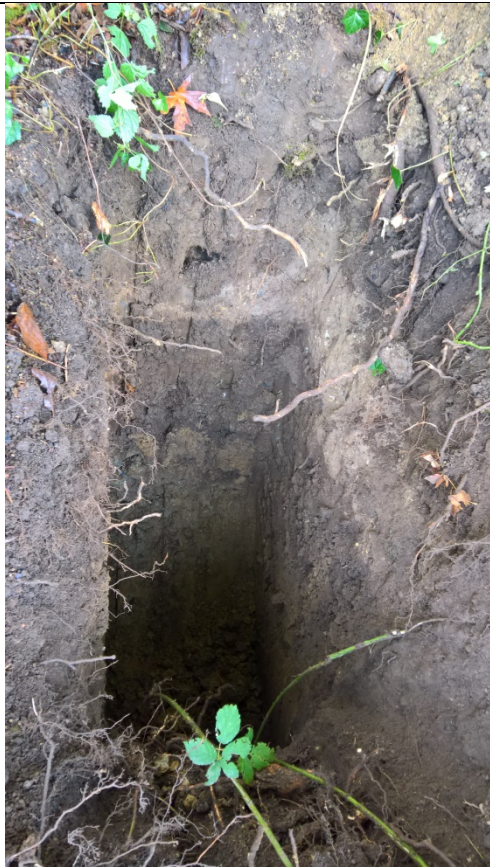
**Test Pit TP-5:** View of south end of Test Pit TP-5. Test Pit is approximately 8 feet deep.

Test pit terminated at 6 feet below grade.
